## Value Appraisal

Year: 2003

Manufacturer: Land Rover

Model: Defender 90

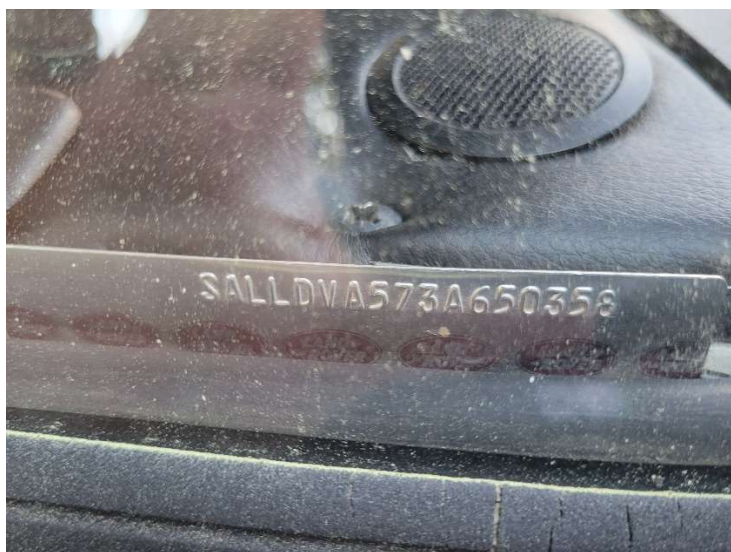
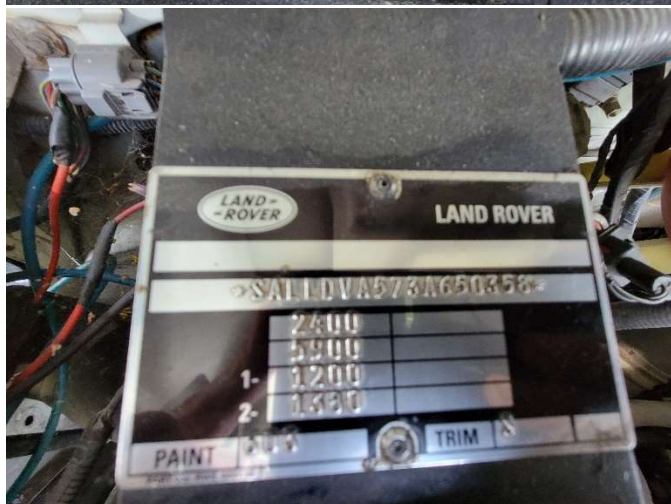
The VIN number as seen through the windshield and name plate in engine bay have been checked against the Ontario ownership (appendix 3) and matches the registered as shown in the below pictures.

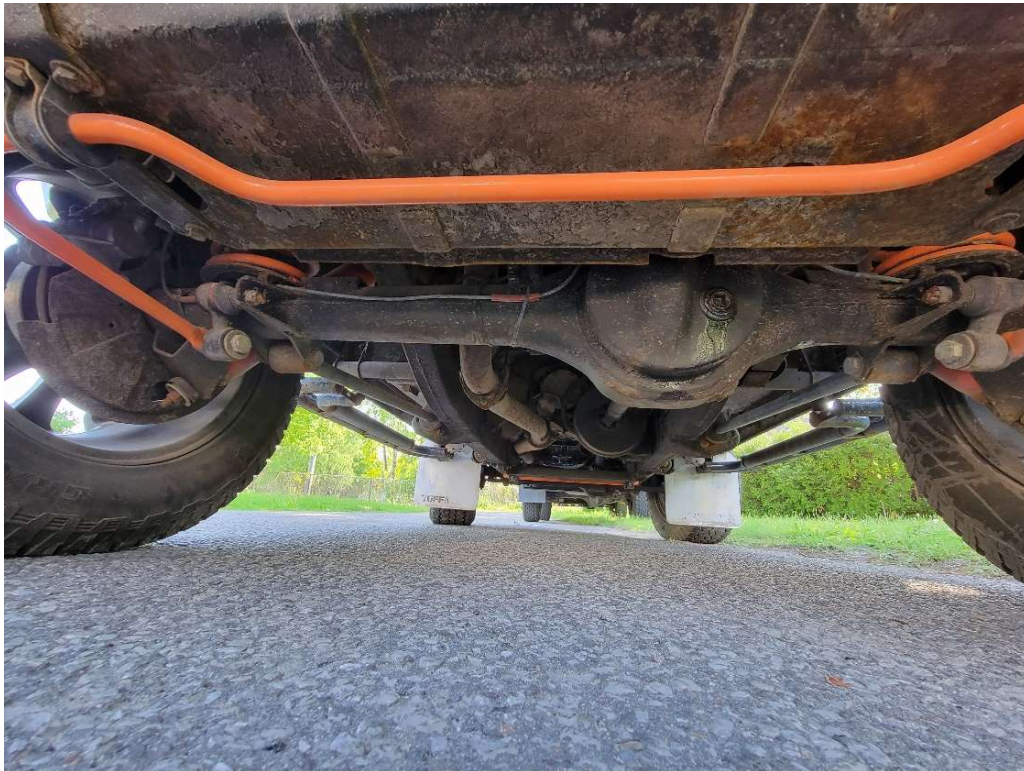
Chassis Rear

The floor, frame and all suspension points are clean and free of any damage and in some cases show very light surface rust. The chassis and suspension points look to have been painted at some point throughout the vehicle's life.

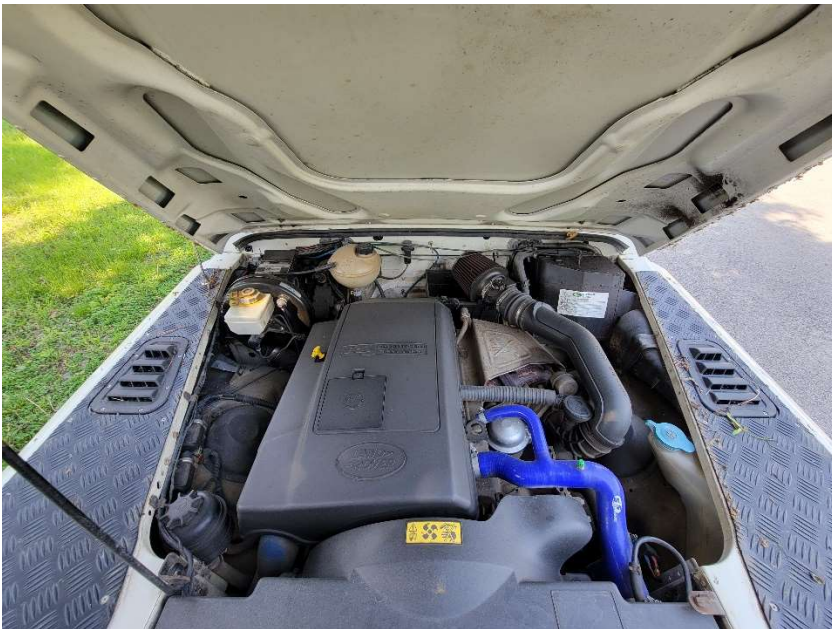
The engine is a Land Rover TD5 Inline 5 cylinder Diesel fitted to a manual transmission.

The engine starts easily and idles properly with no undue noise or smoke. There are no significant oil leaks.

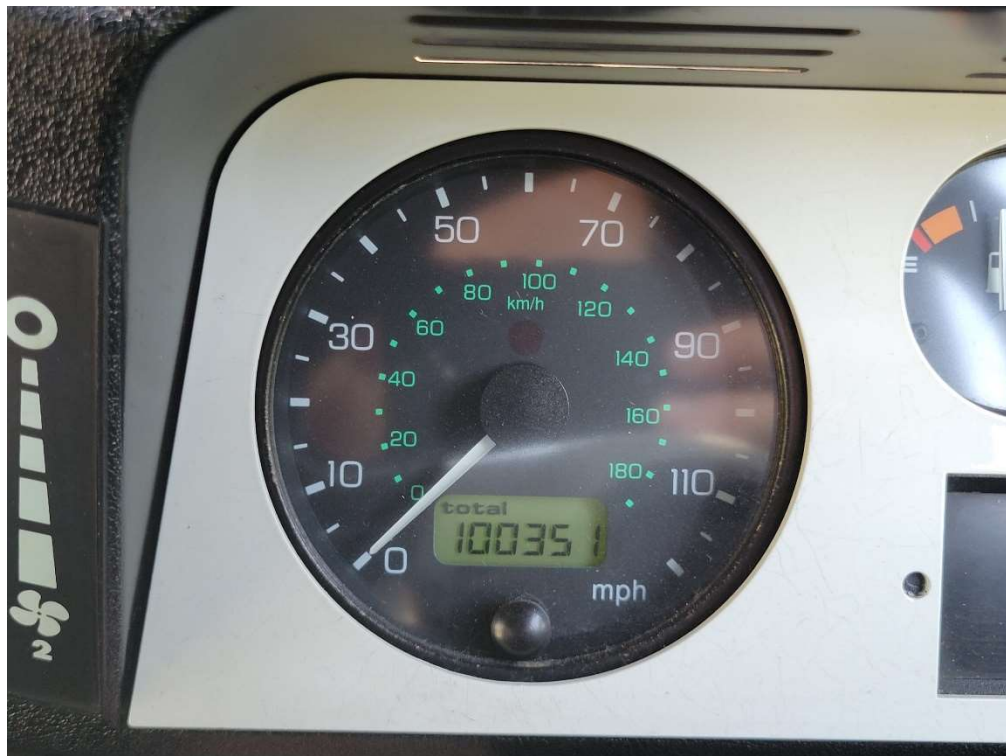
#### Odometer

The odometer reading seen below reads 100351 miles and cannot be verified as original mileage.

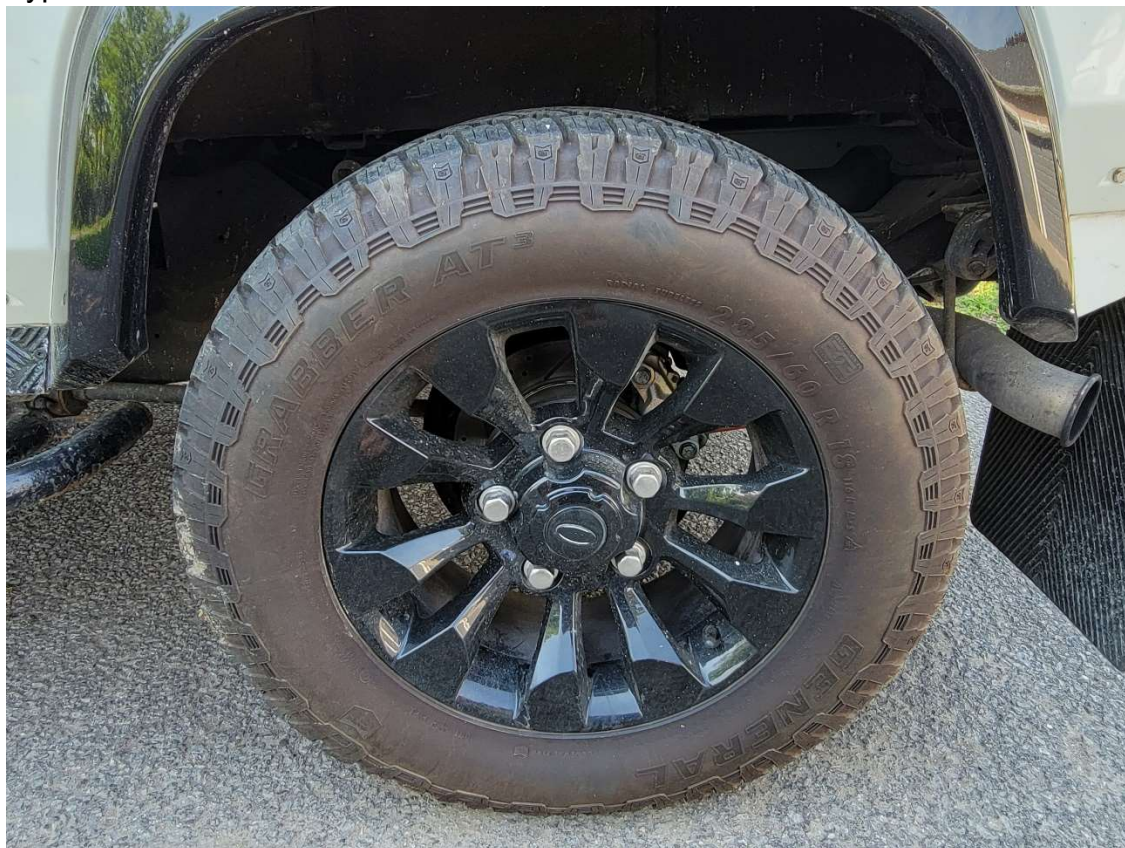
Typical Wheel/Tire

The wheels fitted to the vehicle are 18" Land Rover aluminum wheels that show no visible scratches or "curb" rash. The wheels are wrapped with 285/60R18 General Grabber AT3 tires.

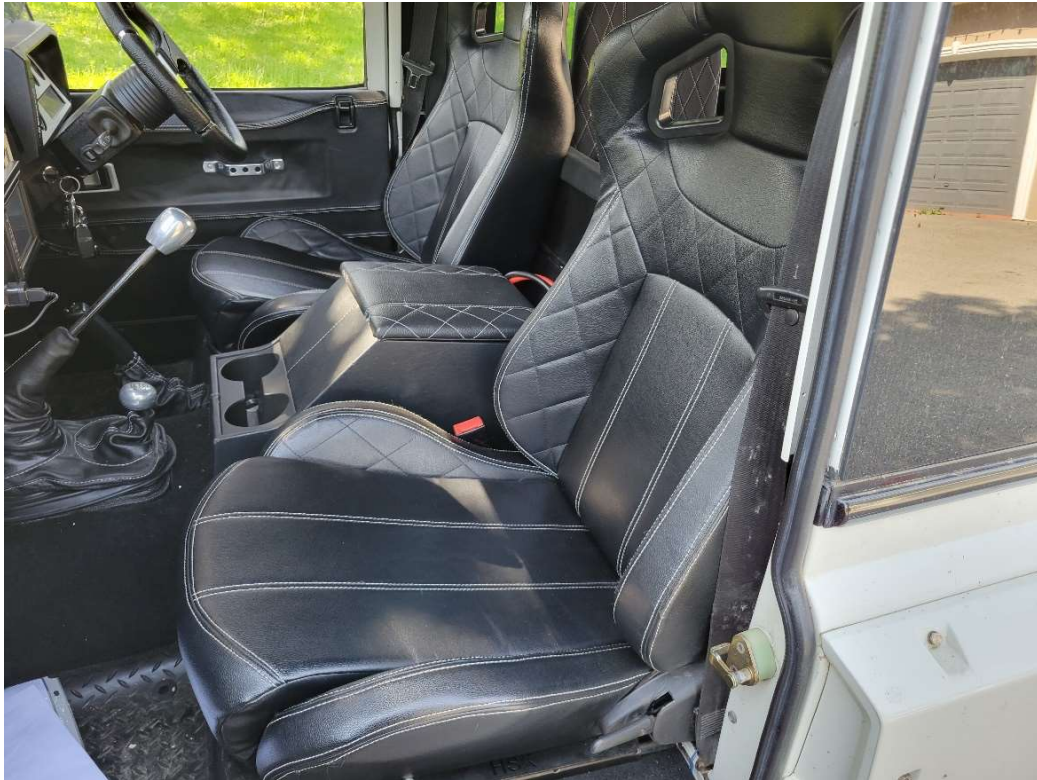
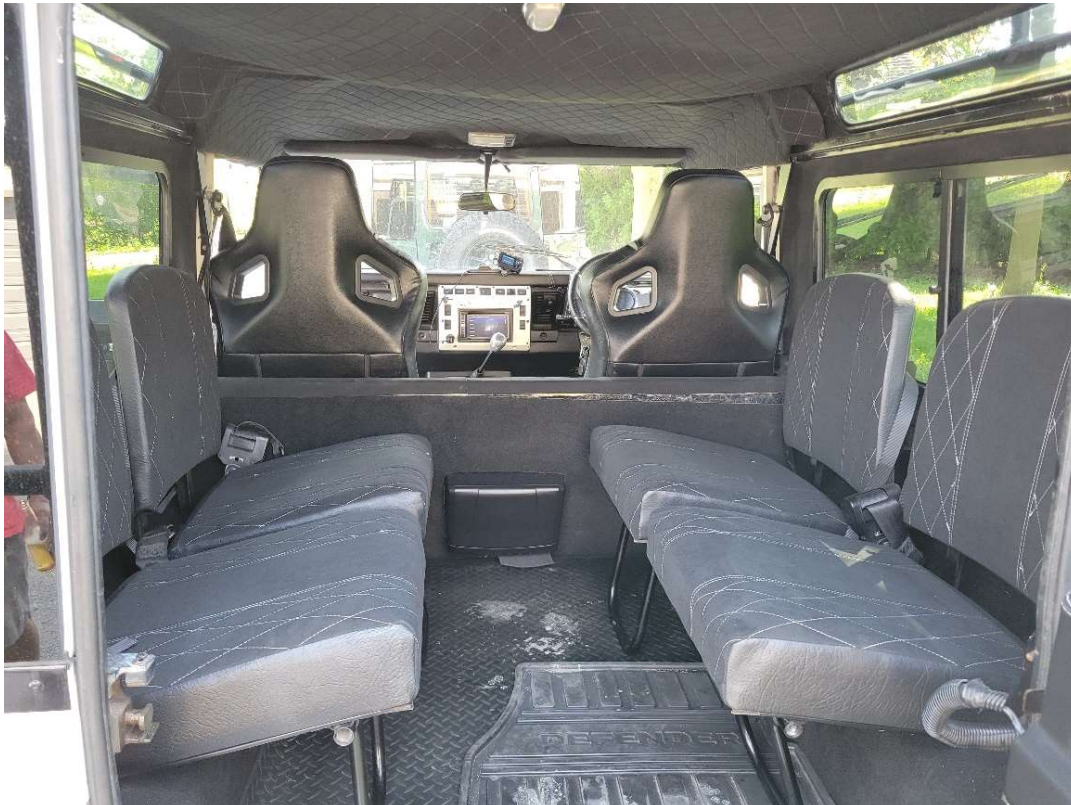
Interior

The interior trim and front seating have been wrapped in black leather with white "baseball" style stitching and the rear seating is wrapped in a mix of black leather and alcantara. The door panels have been wrapped in the same black leather with a white "baseball" style stitching completing a nicely styled custom interior. All doors have been equipped with custom aluminum handles for the door latch, window crank, and door pull. The dashboard is intact and shows two minor tears on the passenger side of the dash. The vehicle is fitted with an aftermarket stereo that operates as intended.
